# WHEN LUCK RUNS OUT

By Michael R. Grüniger,  
Markus Kohler and Capt. Giancarlo Buono  
of Great Circle Services AG (GCS)

## What Seemed Like a Decent Start

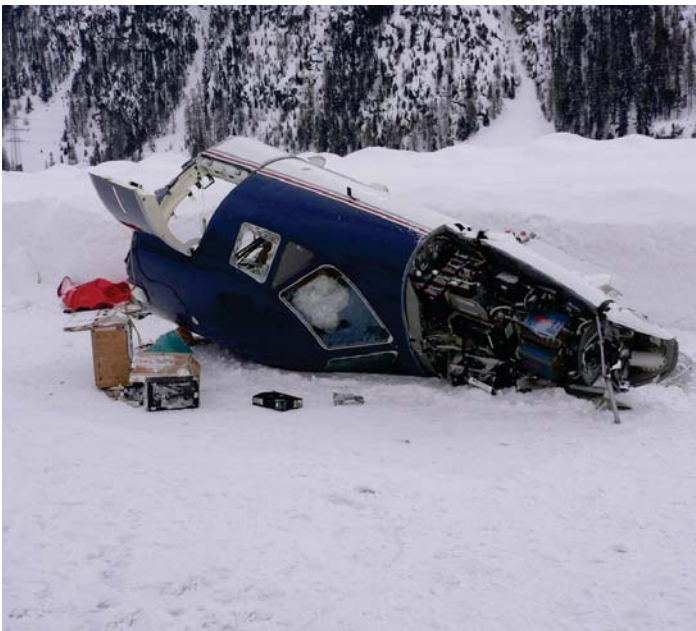
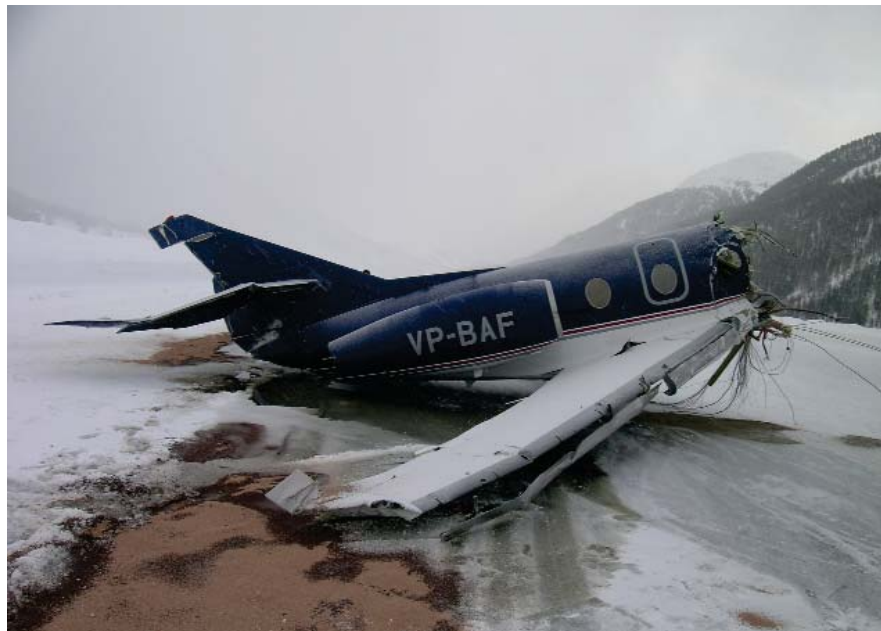
On the fateful flight in 2009, luck ran out. It was reported that the runway was in sight and ten seconds later the aircraft touched down on the runway, 135 m beyond the threshold. The longitudinal axis of the aircraft was pointing 6 to 8 degrees to the right of the centreline axis. The aircraft made first ground contact with the right wingtip some two meters left of the centreline. The main wheels touched down, but the misaligned aircraft drifted to the left, until the left wingtip scraped a bank of snow running parallel to the runway. As a result, the aircraft rotated around its vertical axis and the right side of the fuselage collided with the corner of a compact snow bank, while still travelling at a speed of approximately 107 kts (200 km/h). The fuselage broke into two pieces and skidded for some 150 meters before coming to rest. The two pilots died on impact and the passenger and owner of the aircraft suffered serious injuries.
