# A DEAD WEIGHT

By Michael R. Grüniger  
and Markus Kohler  
of Great Circle Services AG (GCS)

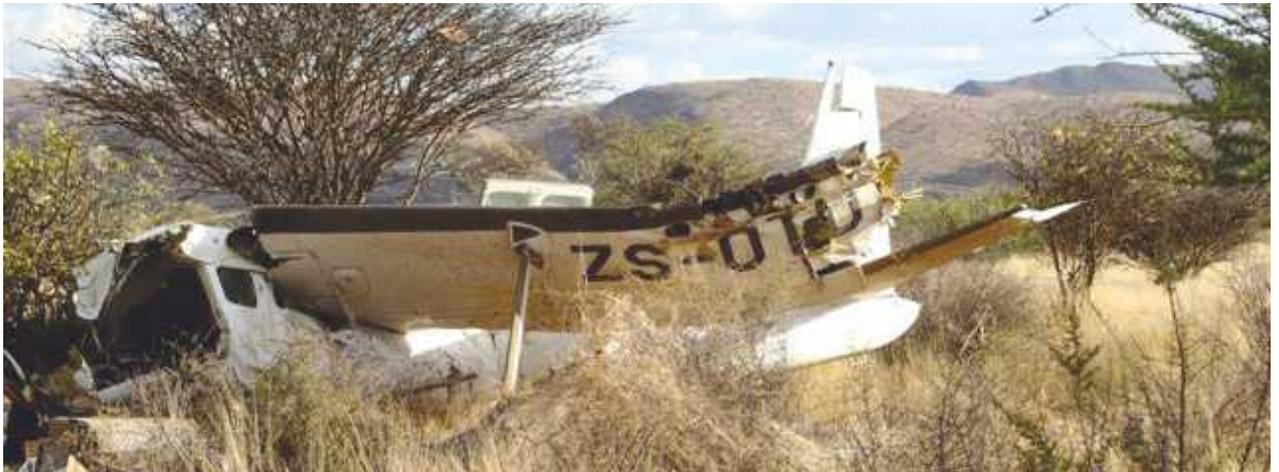
Mass and balance considerations in relation to the power available played an important role in the accident of the ZS-OTU.
