# **FALSE SENSE OF SECURITY**

By Michael R. Grüninger and Markus Kohler of Great Circle Services AG (GCS)

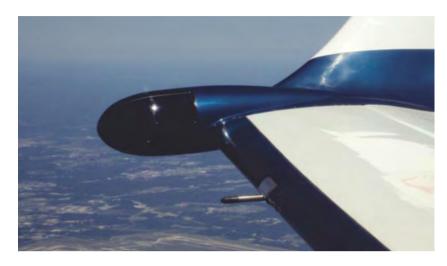
A leak near the #1 static-line (ASI) meant that the two altimeters on a PC-12 gave different indications.
