By Michael R. Grüniger
and Capt. Carl C. Norgren
of Great Circle Services AG (GCS)

COMMITTED TO LAND – WHATEVER THE COST?

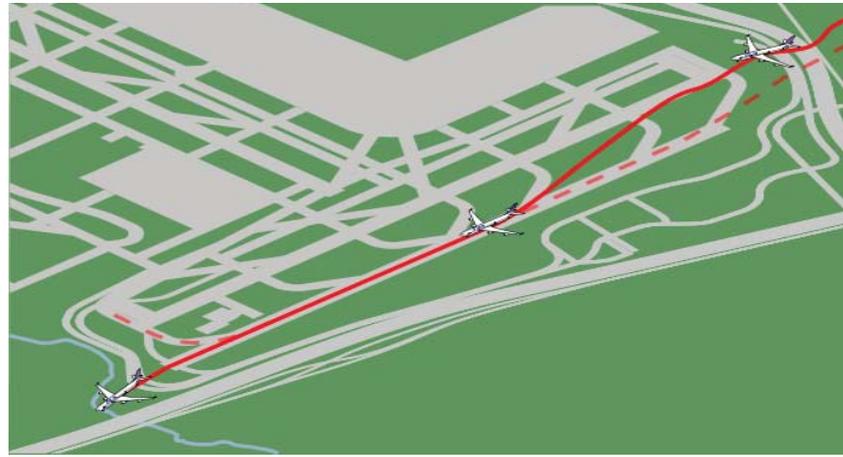
ACCIDENT

The NTSB concluded that the probable cause of the accident was “the captain’s decision to attempt a go-around late in the landing roll with insufficient runway remaining.”

The accident crew did not deploy the lift-dump system fully after touch-down. Only after the co-pilot prompted the commander did he select the air brake from ‘OPEN’ to ‘DUMP’. 17 seconds after touch-down the Captain initiated a go-around, but too late into the landing roll and without following the standard procedure for go-arounds, which would have required a retraction of flaps to position 1 instead of the selected full-up position.

In addition, the wind direction had changed in the vicinity of the storm while the crew was on short final. In fact, the crew probably landed the aircraft with a tailwind component without being aware of it.

N818MV crashed when the right wing touched a localizer antenna pole during an attempted go-around.

One of the lessons learnt from the East Coast Jets Flight 81 tragedy is that a scientific approach to landings would have identified a committed-to-stop point on the runway, after which no go-around should be attempted. Had the crew known that a go-around was no longer feasible, deceleration would have continued to a complete stop. While an exact calculation of such a committed-to-stop point is mathematically complex, such a point

can also be defined by making reference to operational actions. An easy to determine committed-to-stop point is the moment when the lift dump has been deployed or reverse thrust has been engaged.

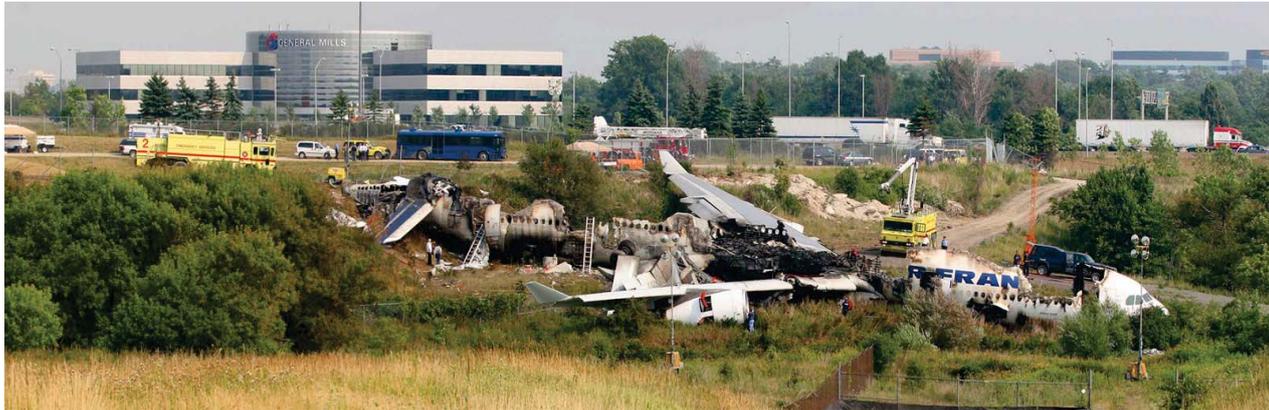
After landing, the pilot flying (PF) struggled with settling the aircraft down and landed high and fast. Under the storm, the headwind had become a tailwind, changing both flight path and ground speed. Reverse power was set only 12 seconds down the runway. The pilot monitoring (PM) probably failed to use standard call-outs. The PF was holding his hand tightly on the throttles to counteract lateral forces exercised by the storm. The accident crew did not call for a go-around.

The aircraft overrun the runway and slid down a ravine at the end of the runway. Passengers and crew succeeded in escaping from the burning aircraft.

OVERRUN
AF 358 crashed when it overran the runway and slid down a ravine.
