SAFETY SENSE

PAYING THE PRICE OF NOT PAYING ATTENTION

By Michael R. Grüninger and Capt. Carl C. Norgren of Great Circle Services AG (GCS)

20. August 2008

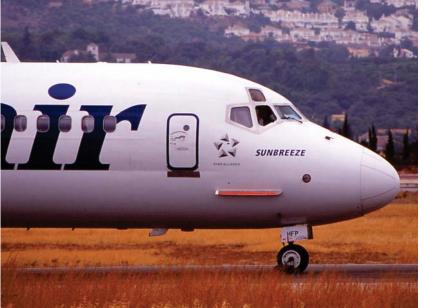
CARELESS

A poorly completed checklist contributed to the Spanair Flight JK5022 crash.

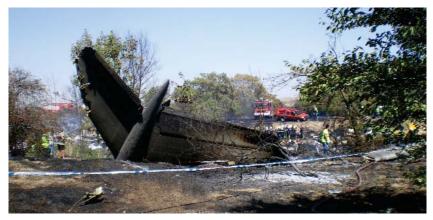
LUCIDITY

A sterile cockpit period can start when the Fasten Seat Belt sign comes on, but be clear on the activities prohibited, or the results may be tragic.
