SAFETY SENSE

RUNWAY EXCURSIONS

By Michael R. Grüniger
and Capt. Carl C. Norgren
of Great Circle Services AG (GCS)

HASTE MAKES WASTE

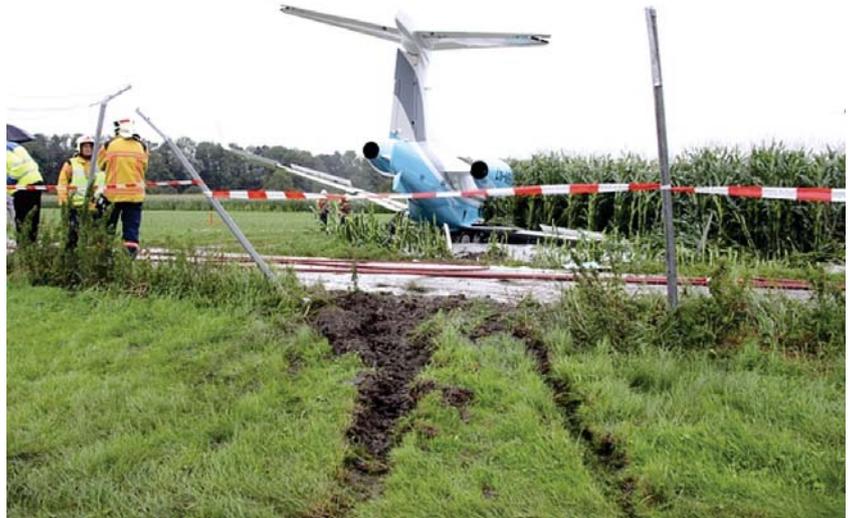
BLURRED

A lack of a clear hierarchy between pilot and co-pilot lead to an accident for EMB-505.

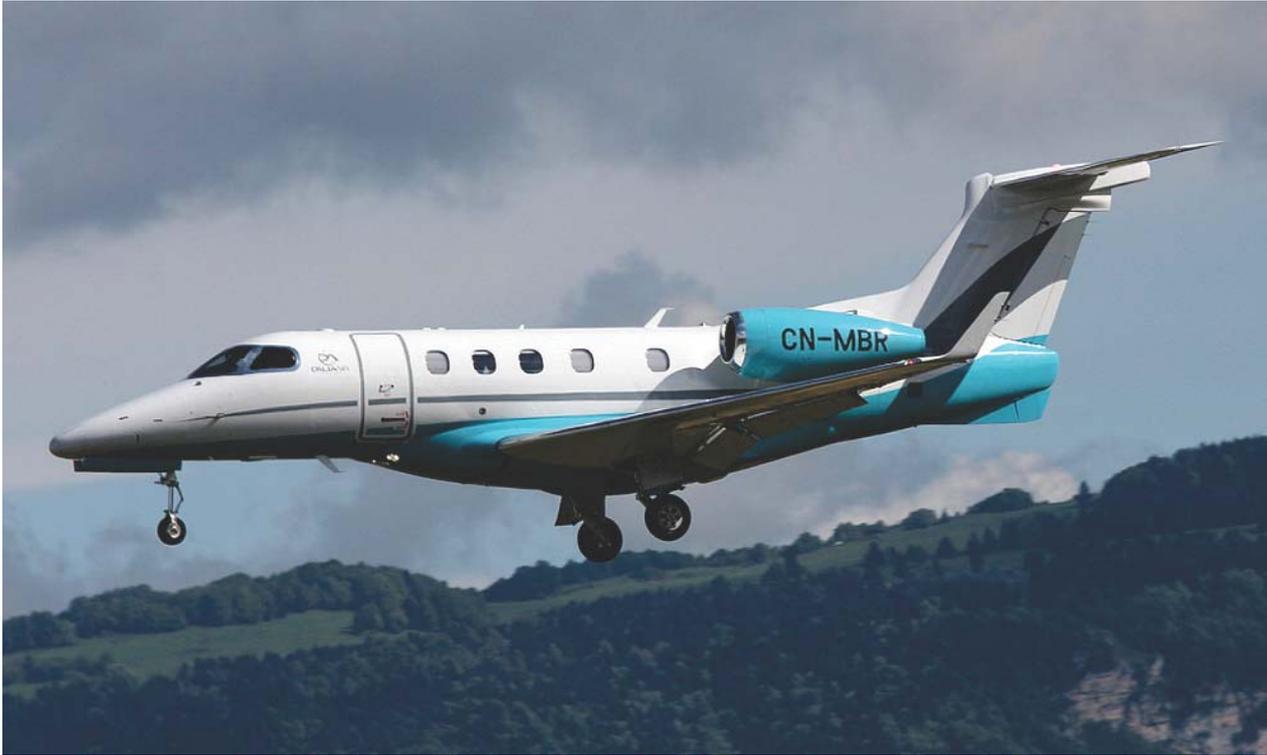
READY
Pilots should be prepared for the short runway at Altenrhein airport.

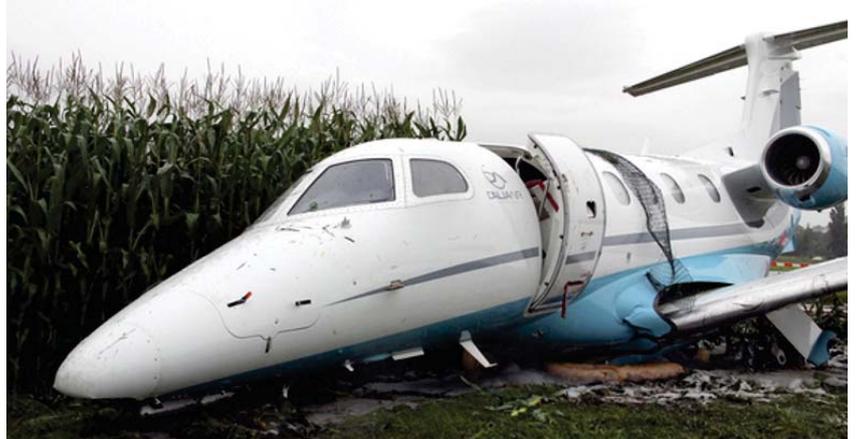
HASTE Most importantly, the flight had Not taking the time to consider all the options led to this accident. another 3 hours of fuel on-board for an extended holding time followed by a diversion to a number of airports in the vicinity with longer runways and approaches into wind.
