JUST HAVING A LITTLE FUN

By Michael R. Grüninger
of Great Circle Services AG (GCS)
and Capt. Carl C. Norgren

JOIN THE '410 CLUB'

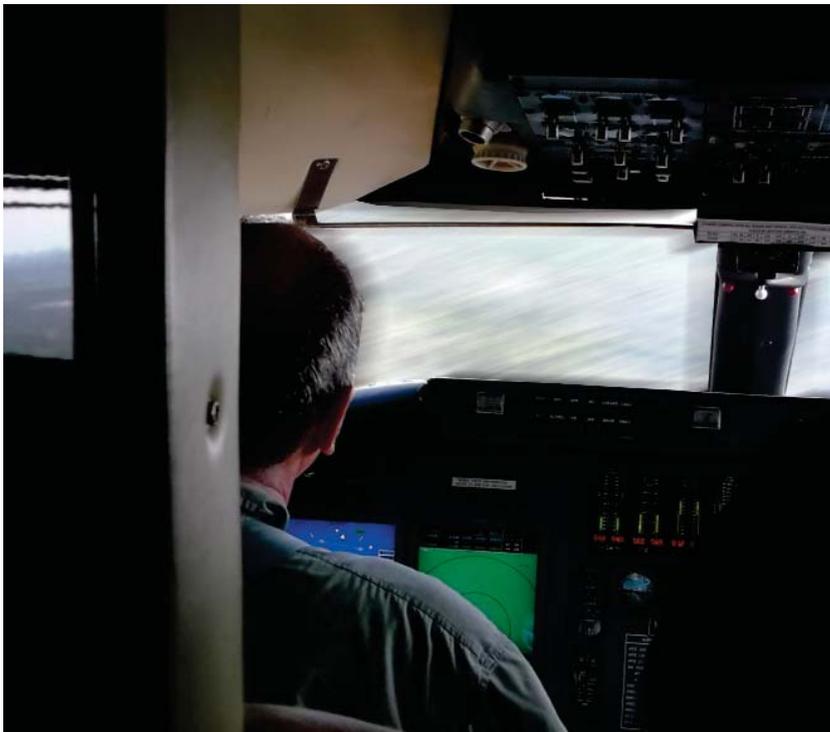
ABNORMAL

By executing non-standard procedures, the pilots of FL410 exerted great pressure on the aircraft.

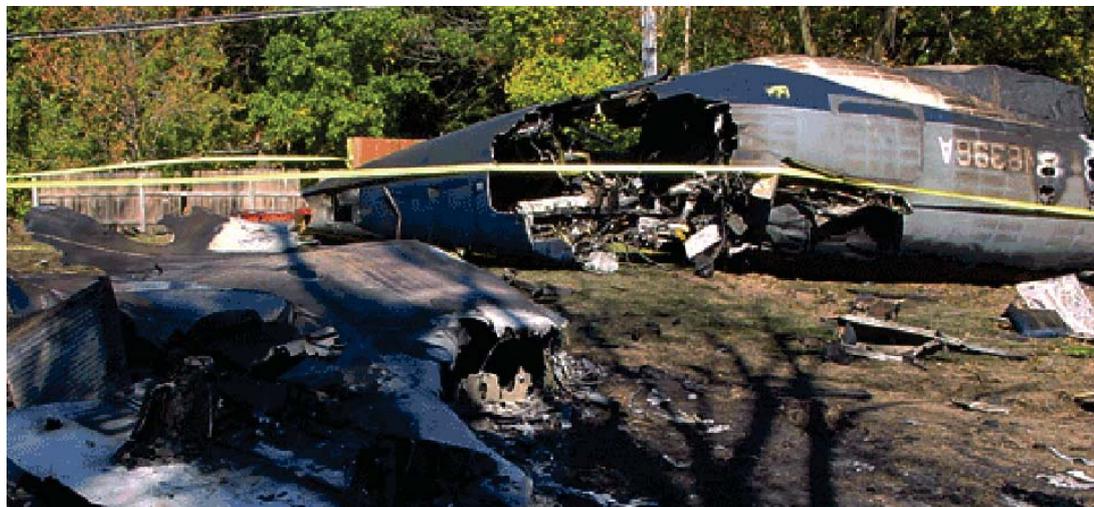
The main airplane wreckage was located at an elevation of 740 feet.
