SUDDENLY IN TROUBLE

Michael R. Grüninger and Capt. Carl C. Norgren share real life experiences and lessons on flight safety challenges, pre-flight calculations

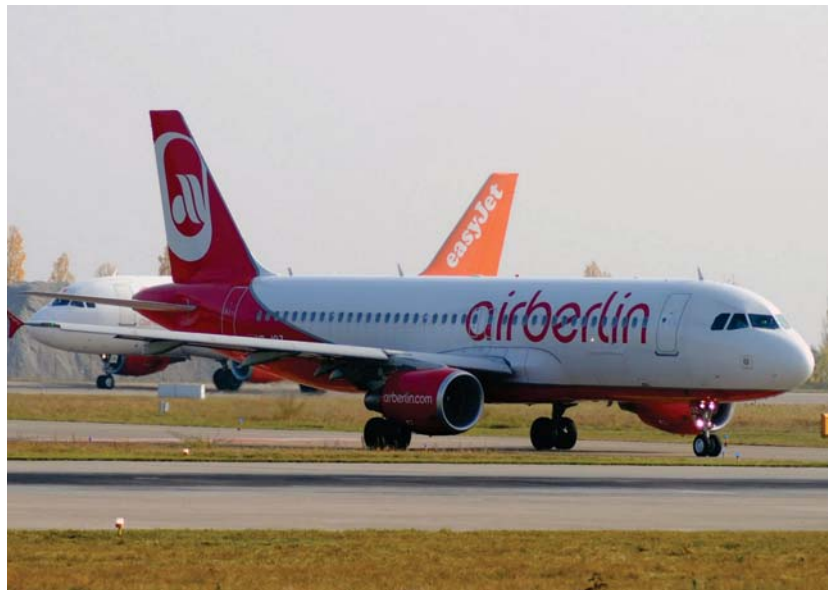
THREAT
Commander and First Officer of Belair flight BHP 2532 faced challenge when taking off the A320-214.

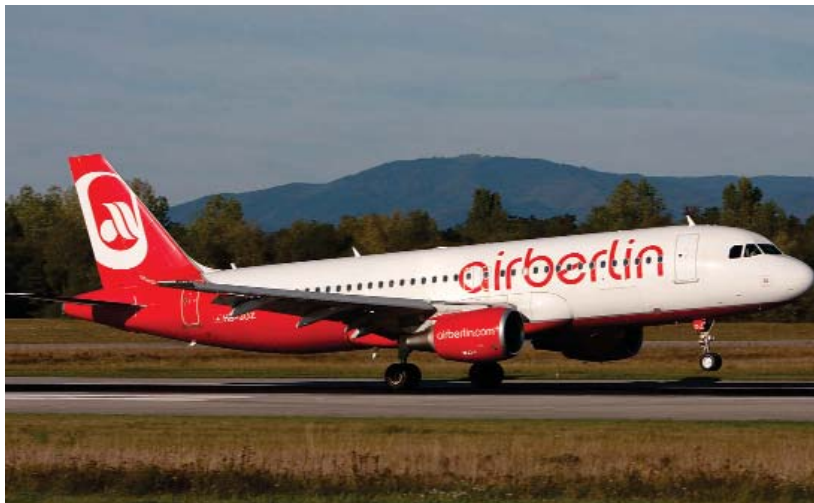
DANGER
Time pressure and multitasking risks are enemies of aviation safety.
