On Sept. 14, 1999, an F900 was subjected to violent vertical load oscillations, which killed most of the passengers, after incorrect crew response to a minor pitch control malfunction. **Michael R. Grüniger and Capt. Carl C. Norgren** analyze the accident and highlight the impact of not following the good practice of wearing seat belts

Struck by Oscillations

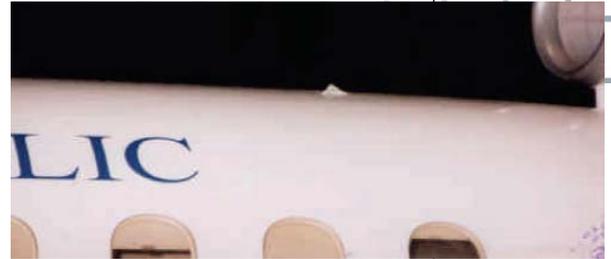
The cabin interior was destroyed. Blood was everywhere. A metal catering container hit the ceiling and penetrated the upper-fuselage skin 127mm by 25mm.

CALAMITY
The fatal accident caused a catering container to stick into the ceiling of the Falcon 900B (top right).
