GROUND COLLISION ON THE ACTIVE RUNWAY

The Linate Airport disaster remains Italy's deadliest air accident, caused by a number of nonfunctioning and nonconforming safety standards and procedures at the airport. **Michael R. Grüniger and Capt. Carl C. Norgren** analyze the causes and general precautions for preventing runway incursions

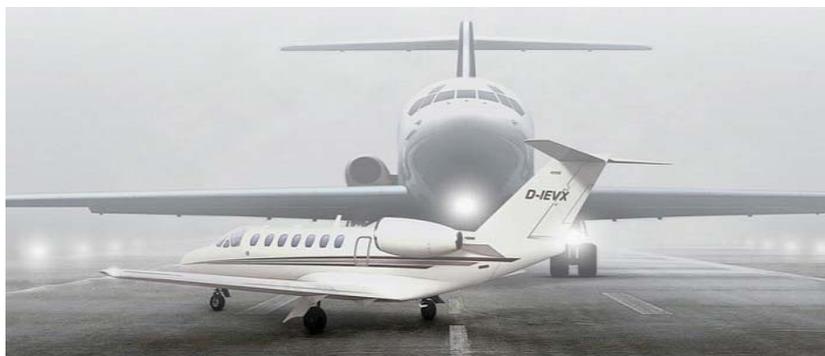
While on the ground frequency, D-IEVX proceeded to cross the active runway at the R6 intersection. At this moment, the Cessna entered the active runway. A runway incursion was the result.

A map of Linate Airport showing the paths of the two aircraft (left). The Cessna Citation Jet and SAS MD-87 involved in the crash (right).

As the MD-87 rotated, it struck D-IEVX with a speed of 146 knots. The Citation Jet was crushed and ripped into three parts as the right hand main landing gear of the MD-87 sliced through the Citation Jet. The Citation was engulfed in fire and the two pilots as well as two passengers perished.

The MD-87 became airborne for a short while, but having lost the right-hand engine and ingested debris in the left-hand engine, the aircraft could not remain airborne. It slid along the runway and crashed into a baggage handling building, causing it to collapse. All 6 crew members, 104 passengers and 4 baggage handlers perished in the ensuing fire.
