I GIVE YOU WING ANTI-ICE LATER IN THE CLIMB OUT, RIGHT?

Michael R. Grüninger and Capt. Carl C. Norgren examine a Challenger 604 that crashed on take-off near Almaty after the captain failed to turn on the anti-icing protection systems despite the low temperature and presence of snow

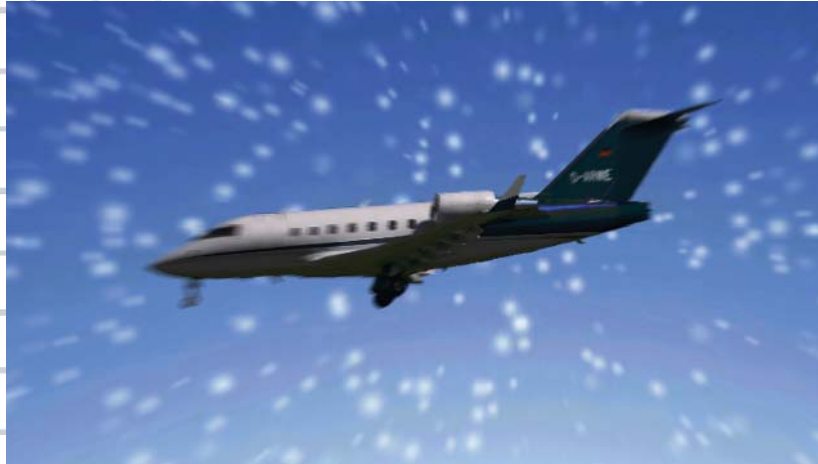
CALAMITY
The accident destroyed the aircraft and killed one member of the crew.
