TOO TIRED?

Michael R. Grüninger and Capt. Carl C. Norgren take a close look at the probable causes of a near-disaster in Denmark, where an incoming SAAB 2000 aircraft descended below minimum safe height

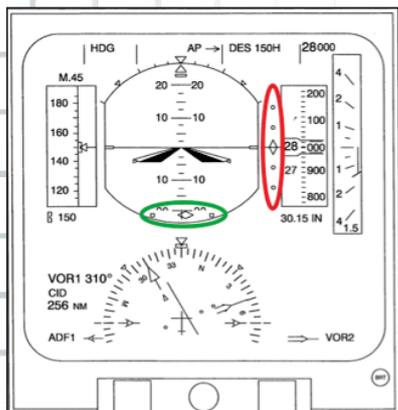
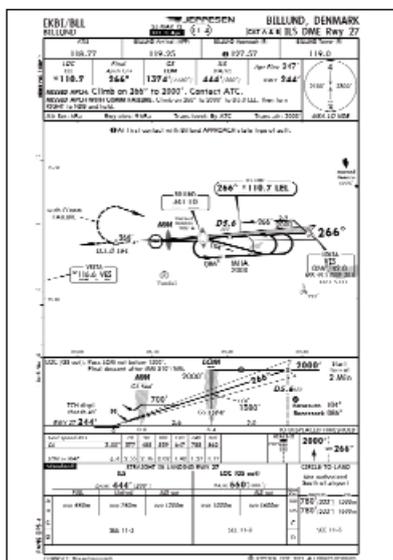
The serious incident emerged from the aircraft's descent below the stipulated min. altitude.

When using the CDFA flight technique the crew must monitor the vertical profile of the aircraft and manually ensure that any altitude steps are complied with. The localizer approach at Billund only has one step that needs to be observed: The outer marker shall be crossed at or above 1,380 ft.

The aircraft descended below this altitude approximately 2.5 nm before the outer marker. Neither pilot flying nor pilot monitoring called for a level-off.

Instead of descending on a 3 degree approach profile, the aircraft descended on a 4.2 degree profile. This was due to the incorrect vertical speed applied. Due to the strong winds the ground speed used for the rate of descent calculation was incorrect. Instead of 140 Kts the air-

craft was flying close to 100 Kts ground speed. At this slower ground speed the vertical speed required for a 3 degree profile would have been around 550 ft/min instead of 800 ft/min.
