Michael R. Grüniger and Capt. Andreas Grauer discuss the risks of leaving safety culture as a loosely defined and adaptable concept through an accident in Geneva in 2017

LANDING WITH PARKING BRAKES ON

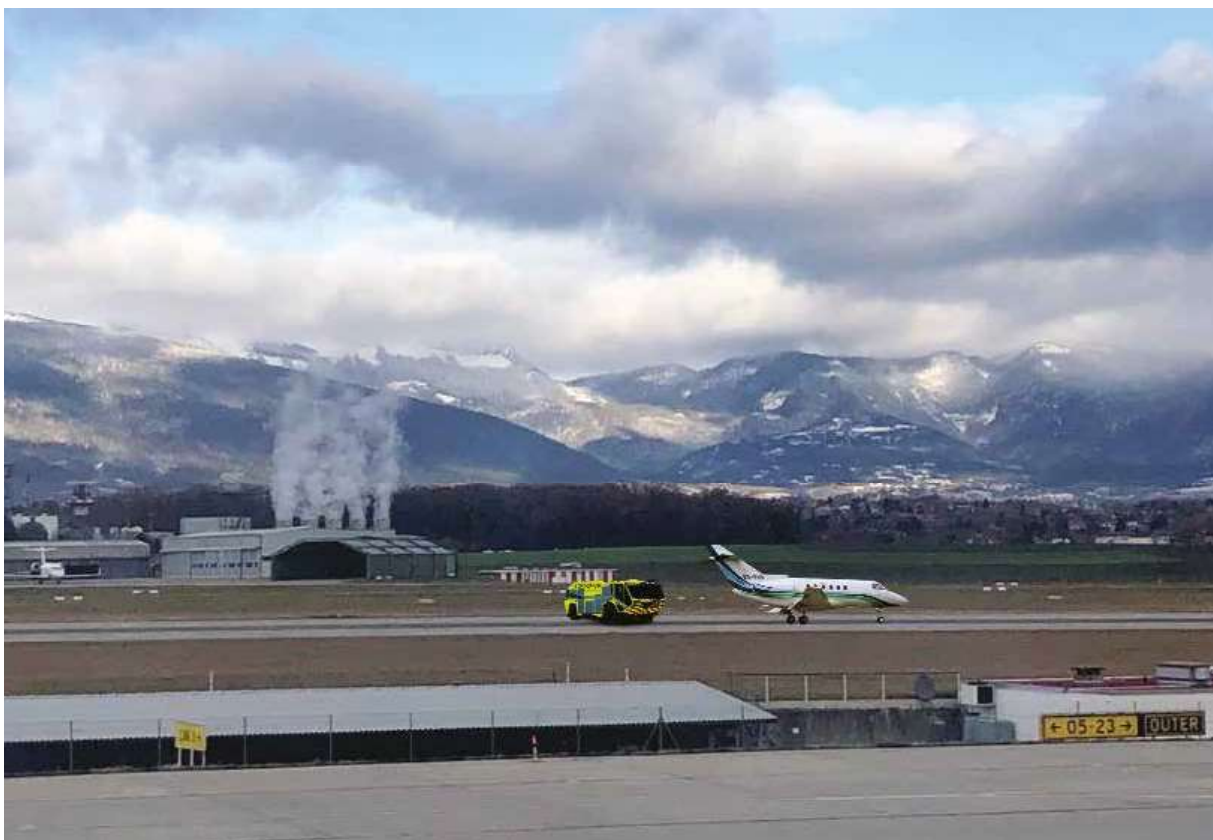
MISHAP
The Runway 05 at Geneva Airport was blocked for 1.3 hours due to an immobilized aircraft.

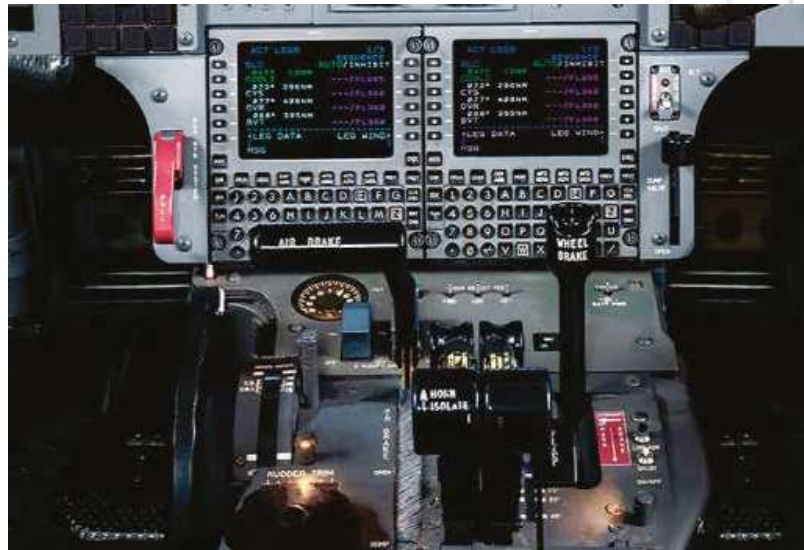
LANDING
Reports show touchdown occurred while the parking brake was applied.
