# FIRE — THE CLOCK IS TICKING FAST

by Michael R. Grüniger  
and Capt. Carl C. Norgren  
of Great Circle Services AG (GCS)

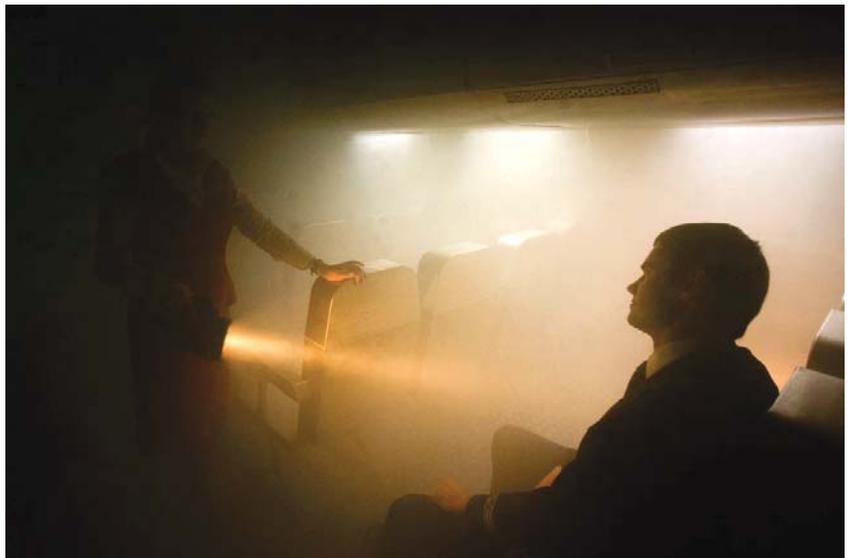
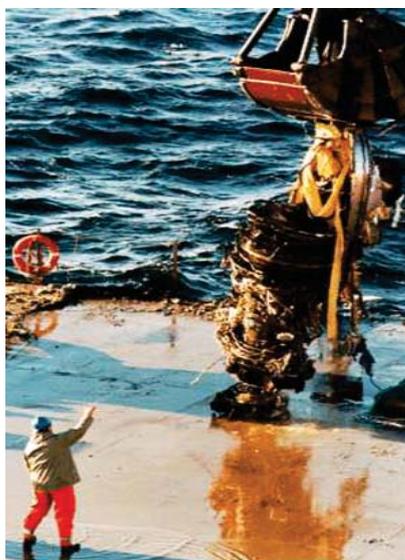
Flight SR 111 (top) was one of a series of aircraft lost due to inflight fire.

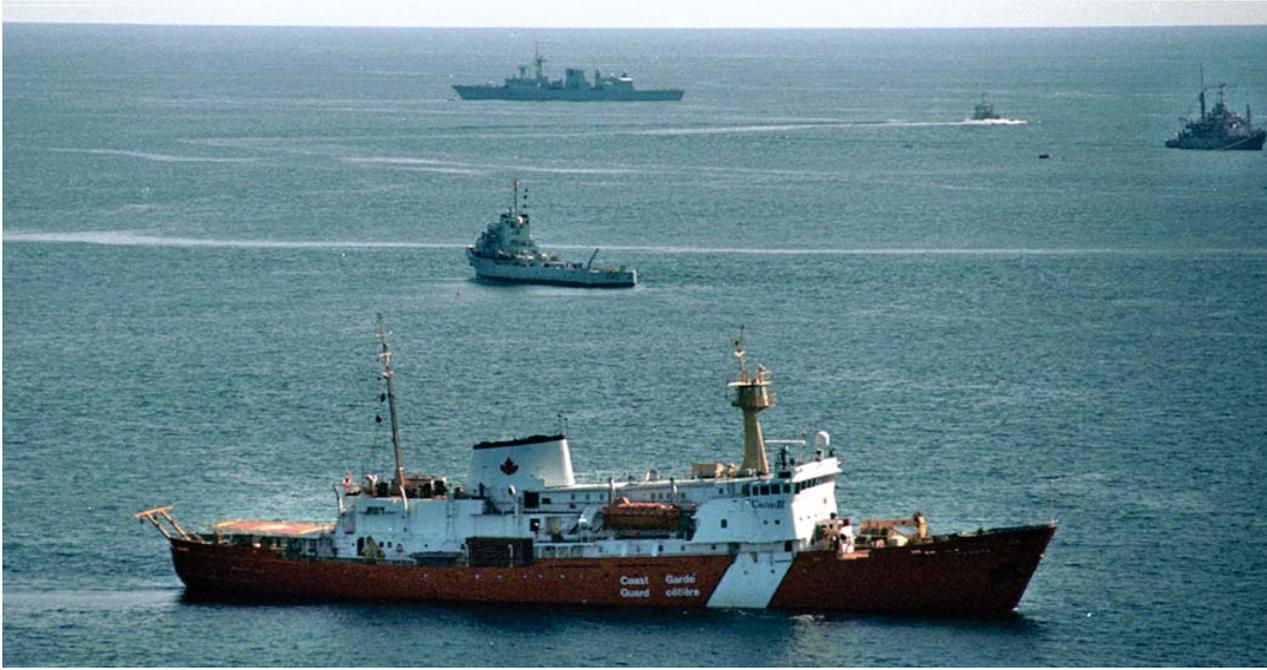
**URGENCY**  
Time is precious during an in-flight fire – the crew on SR 111 decided to dump fuel before landing; a decision that proved fatal.
