## SAFETY SENSE

### DE-ICING

By Michael R. Grüniger  
and Capt. Carl C. Norgren  
of Great Circle Services AG (GCS)

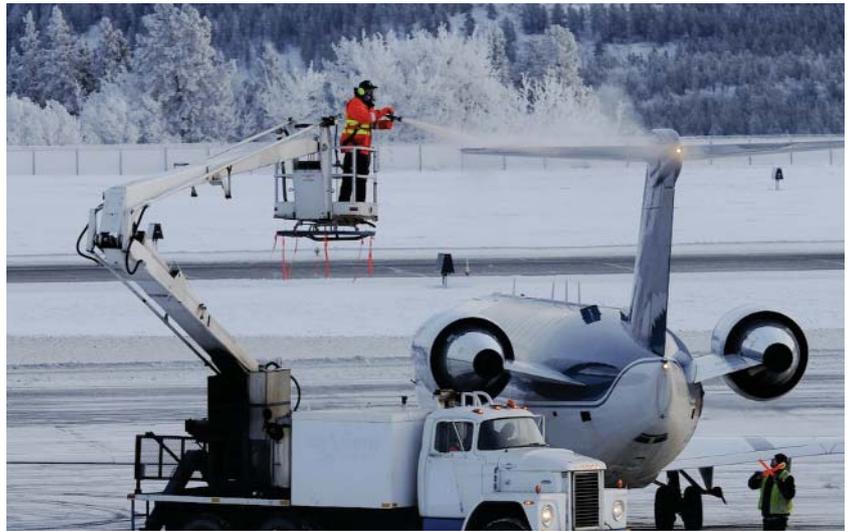
#### VITAL

Neglecting de-icing an aircraft's surface can be seriously compromised.
