OBSERVE, AND THINK OUTSIDE THE BOX

By Michael R. Grüniger
and Capt. Carl C. Norgren
of Great Circle Services AG (GCS)

Landing at Van Nuys, a main landing gear tire of the Global Express suffered a slide-trough failure.

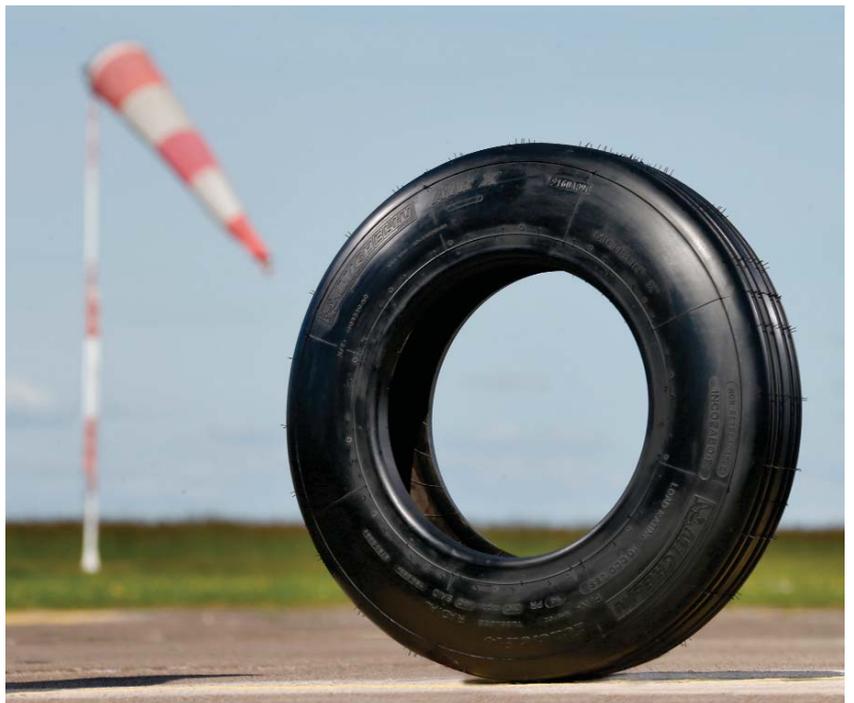
The night flight went on well. The commander touched down the next day at 0808 hours UTC. During the subsequent landing roll, one main landing gear tire suffered a slide-through failure.

Crew and passenger remained unharmed. But the aircraft suffered substantial damage. The left inboard main gear tire had burst resulting from a locked wheel. The flap drive shaft and two hydraulic pipes fractured. Impact damage from flailing sections of the tire also damaged a wiring loom and localized elements of the wing structure. Thus, the flight control system was extensively damaged. A similar failure in a touch-and-go scenario might have resulted in a much less benign outcome.

It seems counterintuitive at first glance that frozen brakes had been the cause for the tire burst in Luton.

The take-off happened in dry weather on a dry runway. And yet, one of the brakes froze once the cold air at high altitude cold soaked the brake assembly.

VP-CRC had been parked on the Tarmac for four days. It had rained a lot in Van Nuys during this period. It was only during the last 8 hours before departure that the weather dried up.

This rainfall had wetted the carbon brakes of which both the rotors and stators are porous and slightly absorbent. To mitigate the risk of frozen brakes, the manufacturer's training material recommended to heat the brake assemblies during taxi by applying the brakes. However, such guidance was not contained in the approved aircraft documentation and it did not specify brake temperature limitations.

As it is common practice in business jet operations to reduce wear and tear of the brakes by avoiding brake applications as far as possible, the pilot of this flight did not dry the brakes sufficiently before take-off. On many smaller airports this would also be hard to accomplish as the distance to taxi to the runway might not be sufficiently long to allow such brake application.

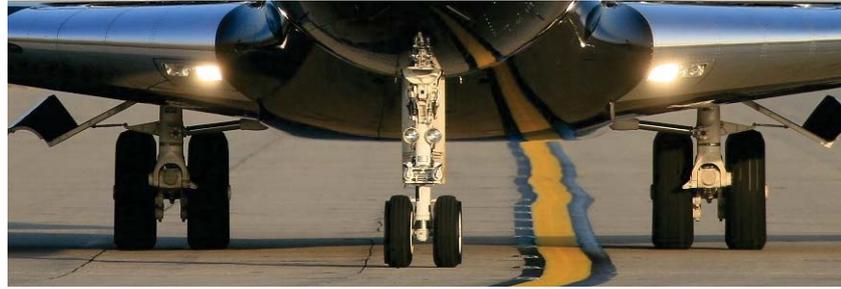
Slide-through events and lateral cutting by debris are at the origin of tire failures in which the tire ruptures. Tire ruptures on take-off can be induced by lateral cutting by debris on the runway such as in the tragic accident of Concorde flight 4590 on July 25, 2000.

Partial or complete separation of large sections of total carcass thickness and substantial portions of the tire sidewall then detach. The flailing section inflicts great damage.
