# IS ANYBODY OUT THERE?

Nowhere else is the communication process more important than in the cockpit of an aircraft, Michael R. Grüniger and Capt. Carl C. Norgren advise through real-life experience

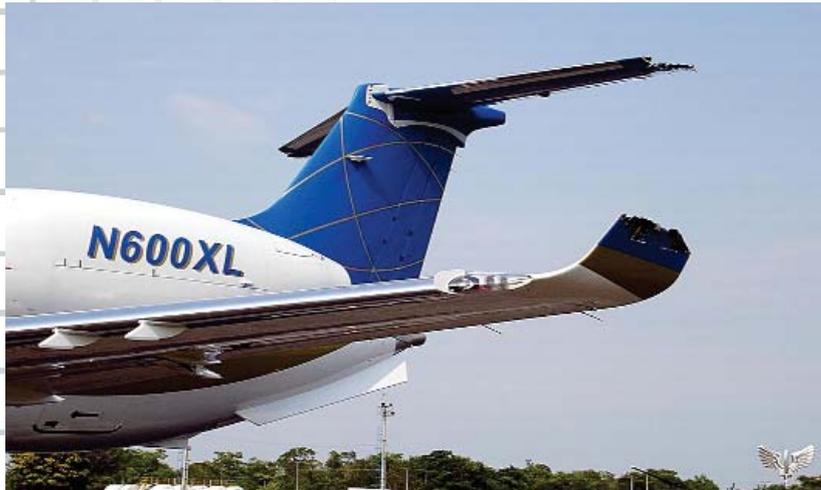
*A breakdown in the communication process often leads to less than desirable events.*

After landing, the crew inspects the aircraft: Part of the left winglet is missing and the left stabilizer and left elevator are damaged. It was a very close call.
