'EVERYTHING IS OK'

At Helsinki Airport in 2012, crew actions following a mechanical failure caused a passenger plane to veer off the runway. Michael R. Grüninger and Capt. Carl C. Norgren examine the reasons

SAFETY SENSE

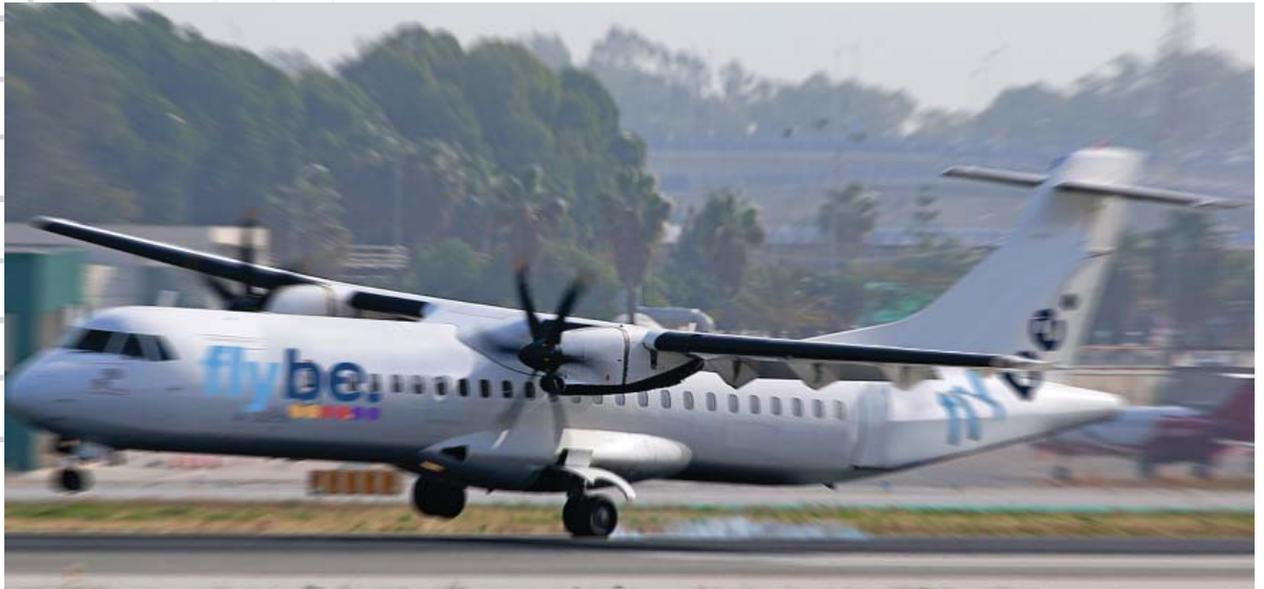
INCURSION
A Flybe airliner veered off the runway during the landing roll at Helsinki in 2012.

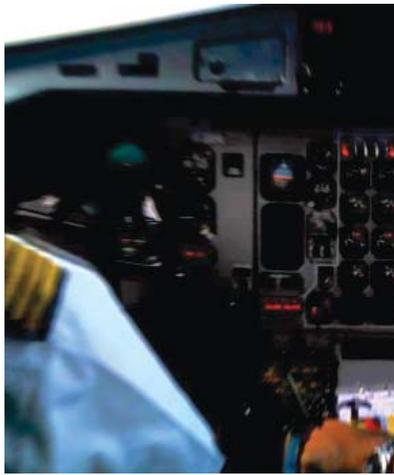
FACTOR
The incident was caused by the rudder's insufficient authority for directional control.
