By Michael R. Grüniger
and Capt. Carl C. Norgren
of Great Circle Services AG (GCS)

COMMITTED TO LAND – WHATEVER THE COST?

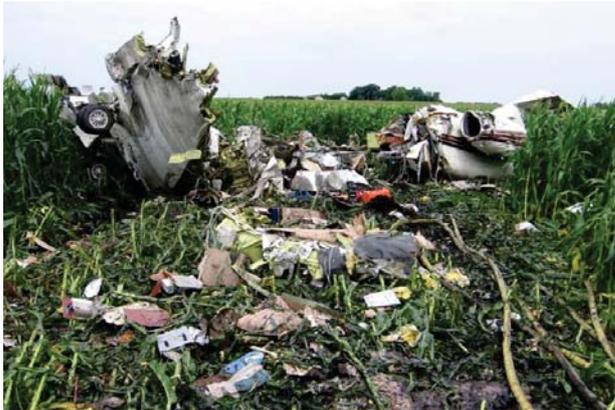
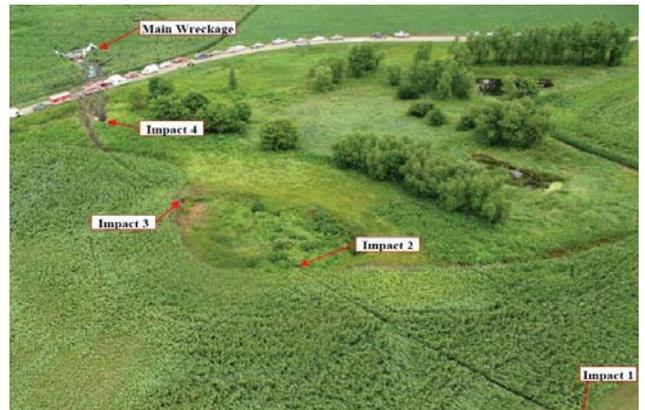
Stormy weather with rain and turbulence were present along the route. Approaching the destination, the crew flew the ILS30 KOWA, pretty much into the prevailing winds with a visibility of more than 10 miles, thunderstorms, clouds scattered at 3,700 feet and overcast at 5,000 feet, and lightning in the distance in all quadrants. Once the crew identified the runway, they cancelled the IFR flight plan. The landing was uneventful, and within the touch-down zone. However, the breaking action was not sufficient and the captain decided to abort the landing and go-around. He applied full thrust and accelerated, but could not get airborne before the end of the runway. The right wing touched the localizer antenna pole during an attempted go-around.

and slid along the ground for several hundred meters, breaking up completely and killing all crew and passengers.

The NTSB concluded that the probable cause of the accident was “the captain’s decision to attempt a go-around late in the landing roll with insufficient runway remaining.”

The accident crew did not deploy the lift-dump system fully after touch-down. Only after the co-pilot prompted the commander did he select the air brake from ‘OPEN’ to ‘DUMP’. 17 seconds after touch-down the Captain initiated a go-around, but too late into the landing roll and without following the standard procedure for go-arounds, which would have required a retraction of flaps to position 1 instead of the selected full-up position.
