SAFETY SENSE

RUNWAY EXCURSIONS

By Michael R. Grüniger
and Capt. Carl C. Norgren
of Great Circle Services AG (GCS)

HASTE MAKES WASTE

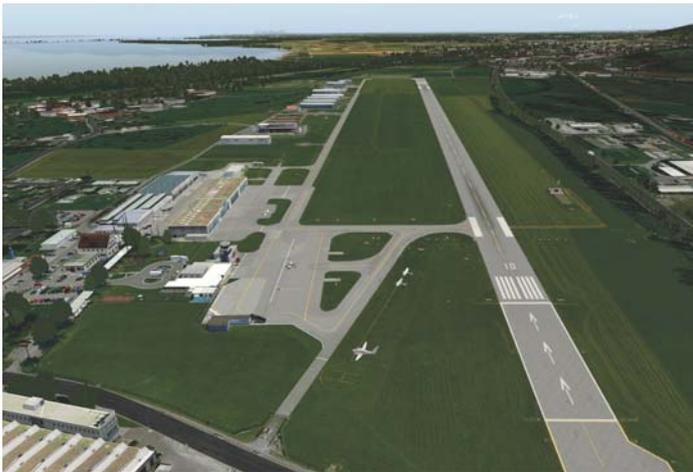
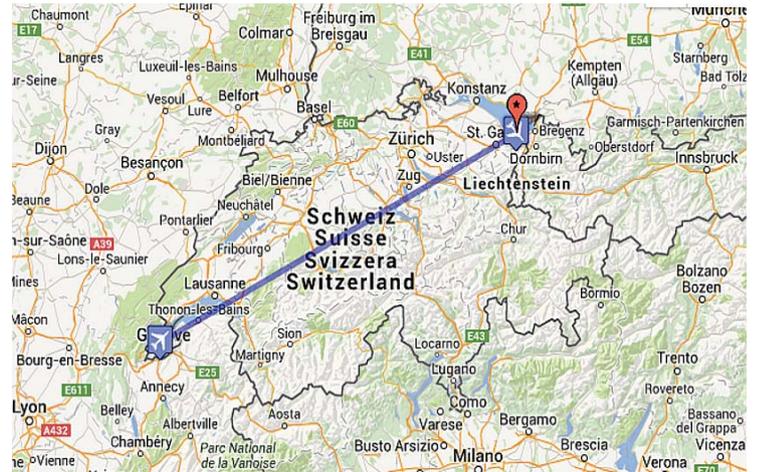
Seconds later the aircraft reached the end of the runway, still travelling at 44 knots IAS. The aircraft exited the runway, broke through the perimeter fence, crossed a road and came to rest in a cornfield. The crew and one passenger exited the aircraft unaided. The Phenom 300 suffered substantial damage.

The first approach had been flown at very high speed. With a strong tailwind the aircraft intercepted the localizer and glideslope at high speed and then struggled to slow down and configure. The gear was extended while descending on the glideslope at 222 Knots IAS at 2'000 ft AAL. Flap 1 was selected at 1'000 ft AAL. At that point the commander requested flap 2 followed by full flaps. The co-pilot selected full-flaps, and 3 seconds later selected flap 3, which was the maximum flap certified for this aircraft. At that point the “FLAP FAIL” warning indication illuminated and the flaps stopped moving. The flaps stayed “jammed” in the Flap 1 position for the remainder of the flight. The aircraft was at this point passing the decision height of 500 ft AAL.

According to the ATIS the crew prepared for an ILS approach to runway 10 followed by a visual circling for runway 28. The prevailing wind according to the ATIS was 340 at 8 Kts. After establishing on the ILS for runway 10 the crew contacted the Tower at Altenrhein. The tower passed an actual wind of 280 at 9 Kts and asked Dalia 211 which runway they would prefer. At this point the aircraft was below 2'000 ft AAL with only the gear extended and travelling at over 200 Kts IAS. Without consulting the captain the co-pilot requested a straight-in landing on runway 10.

taking some time to discuss their options, they would have realized that their altitude, configuration and air-speed did not allow them to successfully accept a straight-in approach for runway 10.
