I GIVE YOU WING ANTI-ICE LATER IN THE CLIMB OUT, RIGHT?

Michael R. Grüninger and Capt. Carl C. Norgren examine a Challenger 604 that crashed on take-off near Almaty after the captain failed to turn on the anti-icing protection systems despite the low temperature and presence of snow

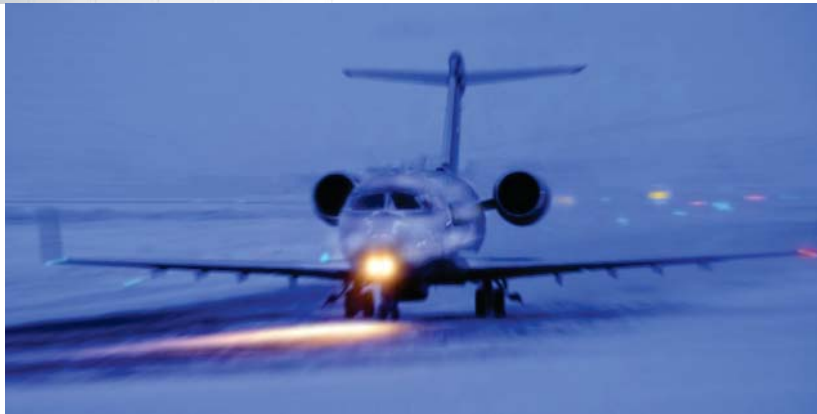
impacted the aerodrome fence and broke into three parts. The subsequent ground fire significantly burned the aircraft.

Taking off with a contaminated wing without engaging the appropriate anti-ice systems as recommended by the AFM and relying on the effectiveness of the ground anti-icing procedure resulted in a stall of the right wing when climbing out of ground effect.

The answer to "I give you Wing Anti-Ice later in the climb out, right?" should have been "No, let's follow the recommended AFM procedure given the current weather situation."
