Michael R. Grüniger and Capt. Andreas Grauer discuss the risks of leaving safety culture as a loosely defined and adaptable concept through an accident in Geneva in 2017

LANDING WITH PARKING BRAKES ON

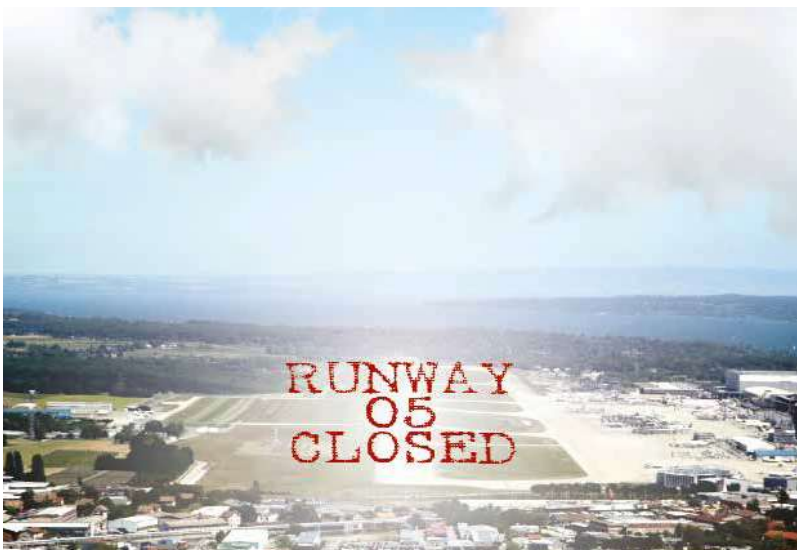
MISHAP
The Runway 05 at Geneva Airport was blocked for 1.3 hours due to an immobilized aircraft.

The main wheel tires of a Hawker Beechcraft 750-HB-33 had

blown up upon landing. The immobilized airplane was not able any longer to exit the runway on own power.

It took the emergency services 1 hour 17 minutes to tow airplane off the runway. Gladly, no personal injuries occurred.
