By Michael R. Grüniger
of Great Circle Services AG (GCS) and
Capt. Carl C. Norgren

AMATEUR
An absence of SOPs led to a Cessna 560 crash in 2001.

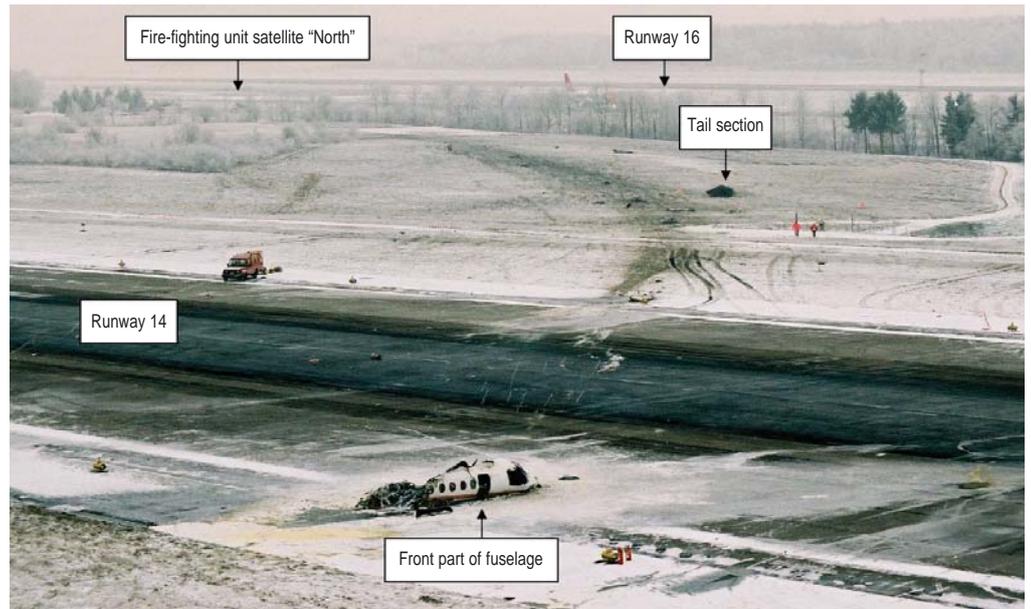
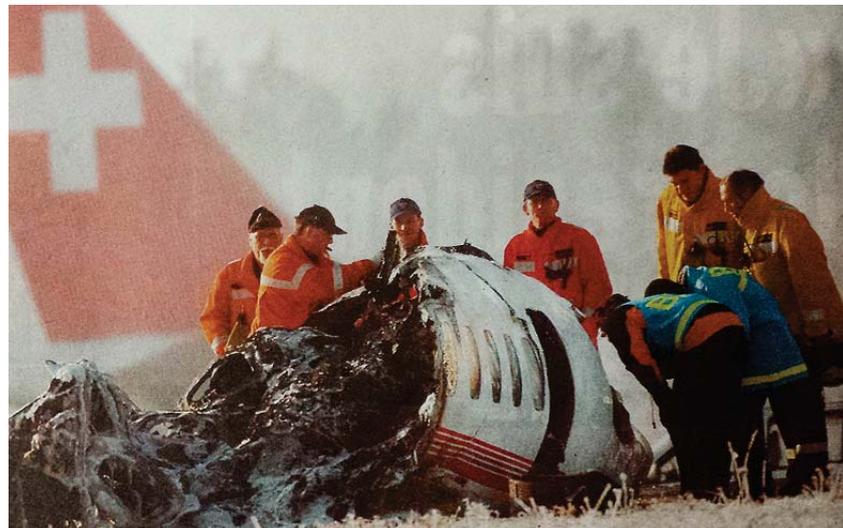
The aircraft lost altitude and accelerated to 230 KIAS. At 22:07 LT the aircraft impacted the frozen ground still within the airport perimeter.

Wreckage and debris covered the area between the departure end of runway 34 and the threshold of runway 14. Both pilots perished.

CRASH
HB VLV impacted the frozen ground within the airport perimeter at Berne airport.
