PROFESSIONAL COOL

A Captain with a History

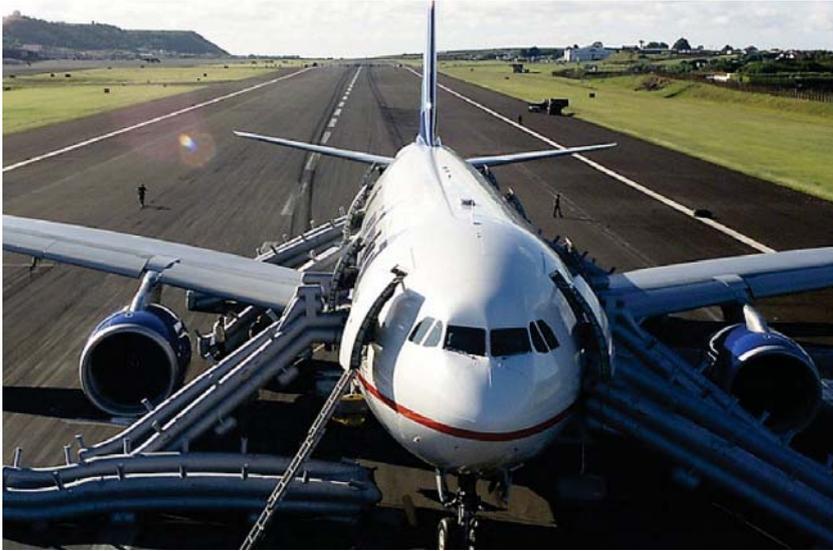
URGENT
Air Transat flight TSC236 in Lajes following the emergency landing.
