SILENCE IS GOLDEN

Michael R. Grüninger and Capt. Carl C. Norgren highlights the importance of effective communication between flight crewmembers through the example of Gulfstream G-IV business aircraft accident

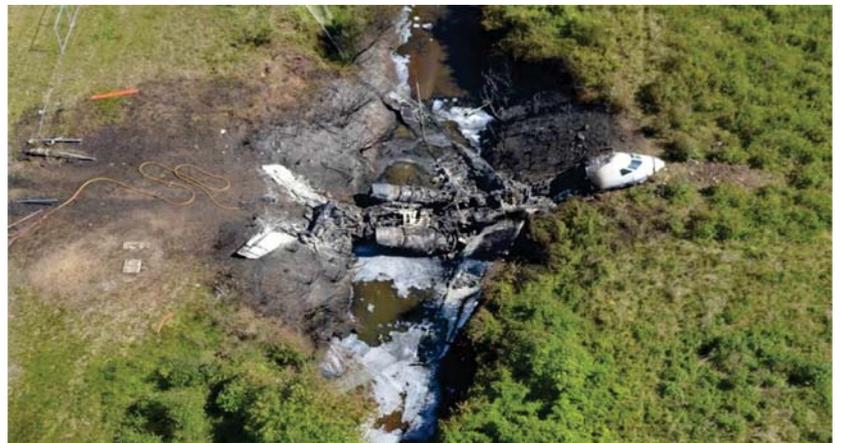
MISHAP

The GIV crashed after overrunning the end of runway 11 during a rejected takeoff at Hanscom Field.

During this time the aircraft continued to accelerate towards the runway end. The PIC retarded the throttles 15 seconds after reaching rotation speed. The airplane overshot the runway, crossed the safety area and fell into a ditch.

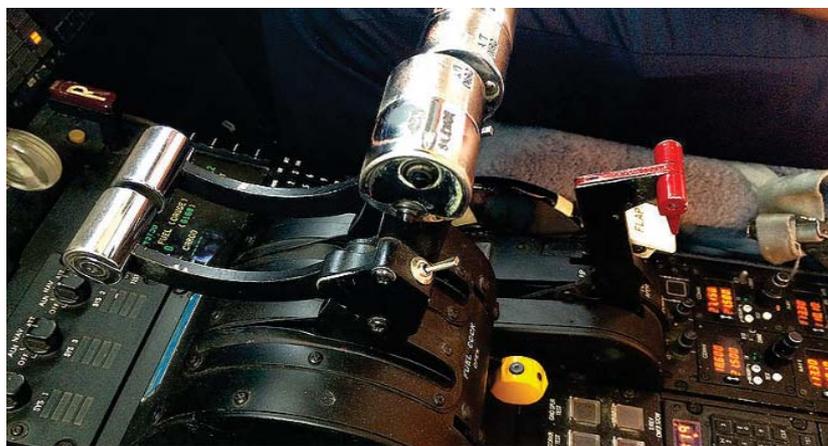
OVERSIGHT
The Gulfstream IV gust lock is at the center of the crash findings.

The G-IV is equipped with a big red handle next to the flap handle on the thrust lever quadrant. It is the gust lock handle. The handle and its mechanism are spring loaded. The spring pushes a lock pin into a slot to prevent the gust lock to either engage or disengage.

The gust lock must be released at the time of the start-up of the engines. In fact, it is one of the items of the start-up checklist. As the crew were

to learn during their take-off, it is impossible to release the gust lock once aerodynamic forces start to apply on the control surfaces.
