ONE PLUS ONE IS TWO. REALLY?

When two pilots qualified to operate alone are flying together, do they add up to performing as a team of two? Michael R. Grüninger and Capt. Andreas Grauer investigate

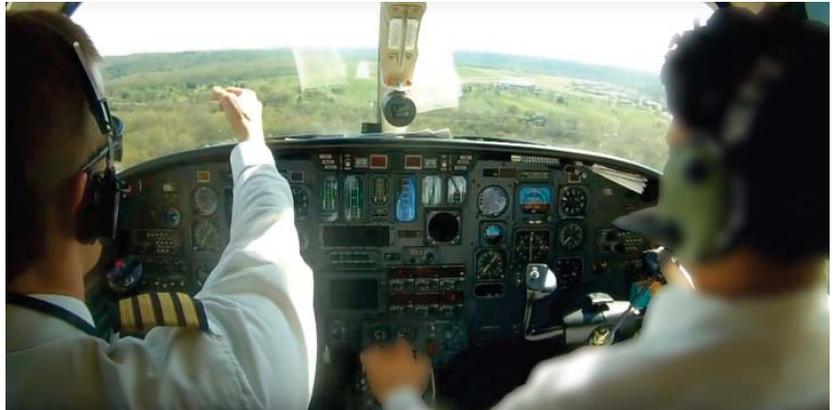
SMASH
A Citation 500 crashed into a house near Biggin Hill Airport from where it had taken off.

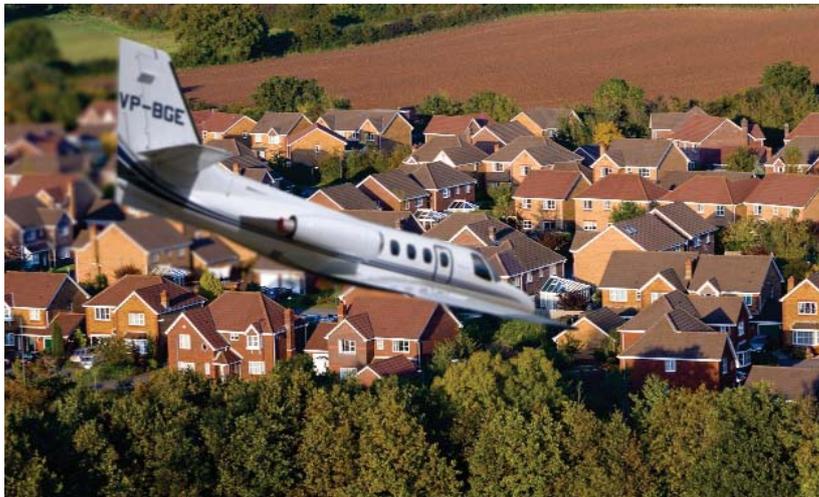
A detached house was completely destroyed in the fireball created as the plane crash landed.
